Dam Safety: Spillway Conduit System Problems

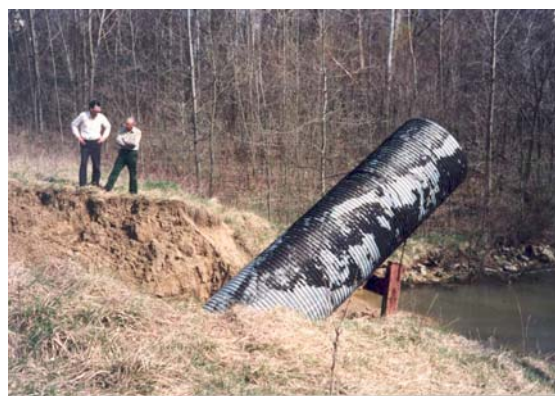
Figure 1 – Undermining of principal spillway conduit

Undermining is the removal of foundation material surrounding a conduit system. Any low areas or unexplained settlement of the earthfill in line with the conduit may indicate that undermining has occurred within the embankment. As erosion continues, undermining of a conduit can lead to displacement and collapse of the pipe sections and cause sloughing, sliding or other forms of instability in the embankment. As the embankment is weakened, a complete failure of the conduit system and, eventually the dam may occur.

Seepage along the conduit from the reservoir can occur as a result of poor compaction around the conduit. If seepage control devices have not been installed, the seepage may remove foundation

material from around the conduit and eventually lead to undermining.
